## INVESTIGATIONS OF SHUTTLE MAIN LANDING GEAR DOOR ENVIRONMENTAL SEALS

Joshua Finkbeiner  
National Aeronautics and Space Administration  
Glenn Research Center  
Cleveland, Ohio

2005 Seal Workshop

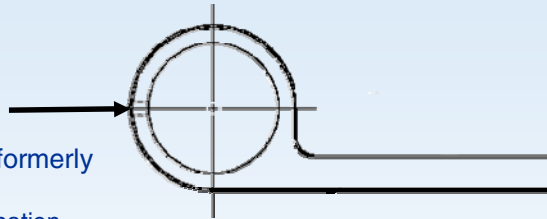
## Description of MLG Environmental Seal

- Silicone rubber core
- Nomex fabric overwrap
- Vent holes every 6 in.
- Two revisions
  - Rev. M - old revision (formerly flown)
    - Nomex fabric impregnation
    - Higher stiffness
  - Rev. P - new revision (installed on STS-114)
    - Material slightly darker than Rev. M
    - No Nomex impregnation
    - Lower stiffness

Since the seals are designed to work in space (i.e. vacuum conditions), vent holes are included every 6 in. in the front of the seal bulb. These holes allow pressure in the interior of the bulb to vent to ambient pressure, preventing damage to the seals.

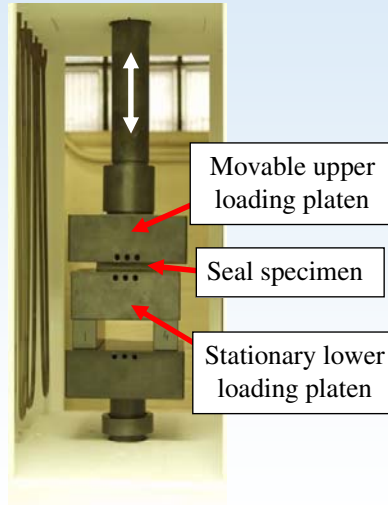
## Description of MLG Seal Compression Testing

- Measure load vs. compression
- 5-in. length of MLG door seal
- Room temperature compression tests
- Exploratory testing
  - Understand loading conditions
  - Recommendations for reduction in seal load generation
  - Select setup/mounting conditions for systematic tests
- Systematic testing
  - Compare Rev. P to Rev. M
  - Fill out seal performance database

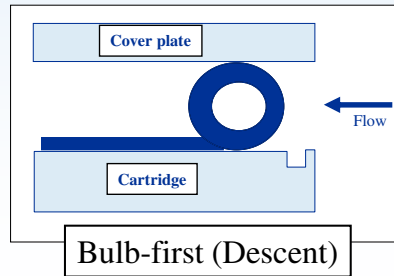
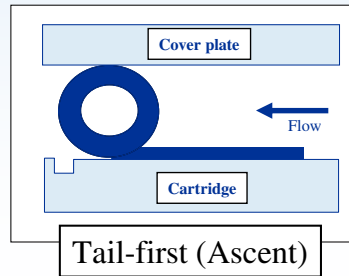
## Description of MLG Seal Flow Testing

- Flow rate measured as a function of:
  - Pressure drop across seal
  - Seal compression
- Two specimen orientations

- Bulb-first (descent) flow rates below 3 SCFM/ft leakage limit
- Tail-first (ascent) flow rates much higher at low compressions
- Effect of orientation disappears by 25% compression
